## FLEXNEWS

JUNE, 2008

### THE POWER OF FLEXKRETE, IT'S ADHESION, DURABILITY & SIMPLICITY!

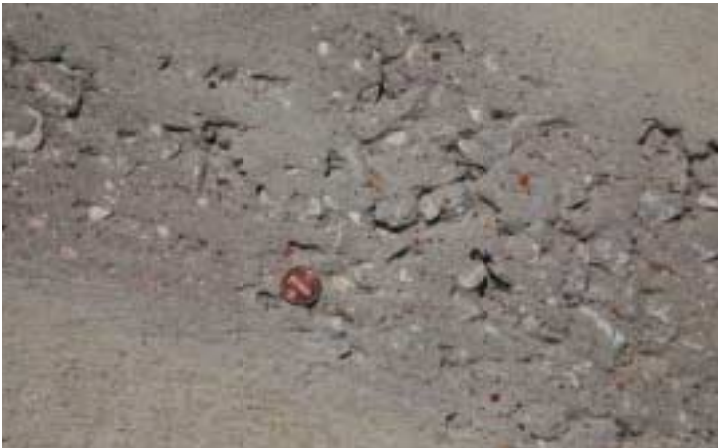
McCarthy Construction recently called to ask us to look at a new bridge they had just built on I-30 in Dallas, TX. The deck finish was left with voids averaging the size of a penny or smaller, most less than a 1/4" deep, and encompassing much of the entire deck surface. The question was: Can these tiny voids be filled with FlexKrete, and will they remain in place when grooves are saw-cut across the deck? These grooves will be 1/8" wide, 3/4" apart, and 1/4" deep, so we are asking the material to, not only withstand the blade impact, but to remain in place after being cut into fragments. Also, would these shallow micro patches withstand the constant beating of thousands of cars and trucks each day, and the vibration and movement of the bridge itself? After 30+ years in this business, we know of no other material, either past or present, that we would have given any chance of success in this situation! Not, however, until FlexKrete.

The voids spanned across most of the entire deck in a transverse pattern. **The repair procedure** was simple and quick. FlexPrime was "dobbed" with a brush into each hole, removing excess material with the "dry-brush" effect.

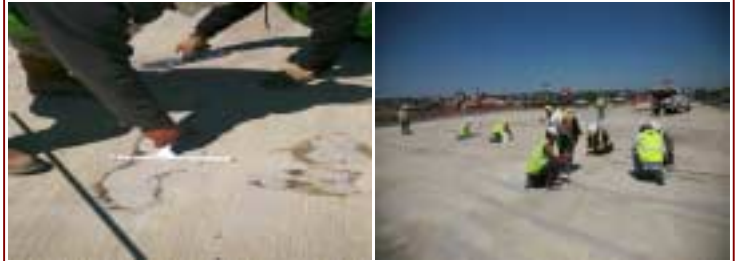
Next, after mixing the catalyst with FlexKrete, two parts fine blasting sand was mixed in for about one minute, poured onto the surface, and with a small hand squeegee, the material was forced into the voids. A very thin coat of FlexKrete is all that was left on the surface, and even this thin material stayed intact when the deck was grooved.

All the repaired areas were barely noticeable after the grooves were cut, and after a small amount of traffic, they will be virtually invisible.

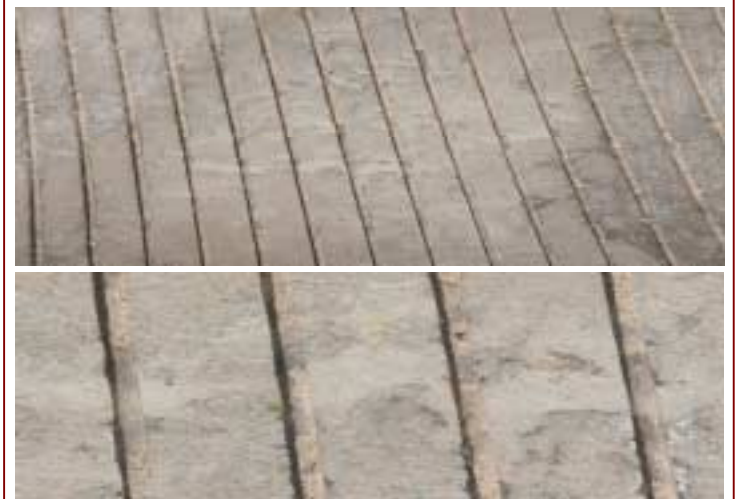
The pictures below show the finished repair up close. The lighter colored spots are where the actual voids existed and were filled. In the top photo you can tell where the thin material was spread over the deck as it was "squeegeed". All the filled voids show straight saw-cut lines, with no break-out in any area.

Although the entire repair required only about four gallons of FlexKrete, the result is not insignificant. Indeed, it is further indication as to the phenomenal adhesion and strength of the product, and will, for many years to come, show its tough durability and longevity, which has been proven over and over again for the past eight years of its existence.

Had this job been repaired by the conventional method, it would obviously have been labor intensive and exorbitant in cost. With FlexKrete, it was only about 4 gallons of material and about three hours for completion.

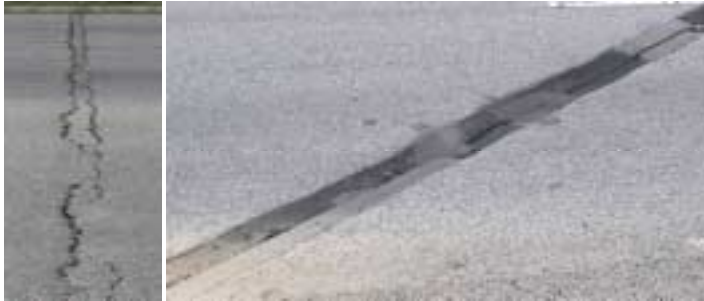
With a 2" asphalt overlay, the pictures below show one joint without header joint material, (crumbled), and the other one with failed product. FlexKrete can quickly and inexpensively solve this problem for the long-term.

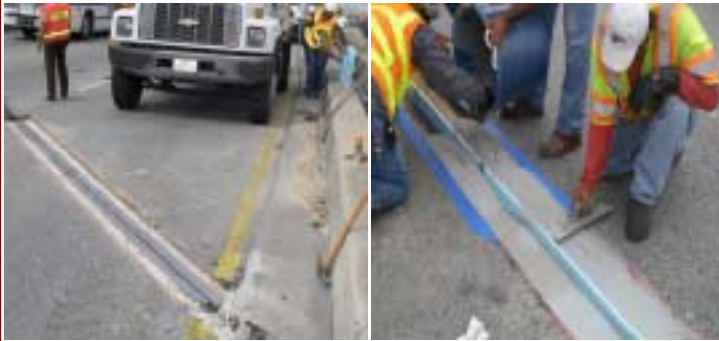
The proper way to install new header joint material is to cut the overlay back to the desired distance, 6"-8" on each side of the joint, then blast clean the area. Tape can be placed along the edge of the asphalt to maintain a straight line. A spacer board should be used to fill the joint while the FlexKrete is troweled into place.

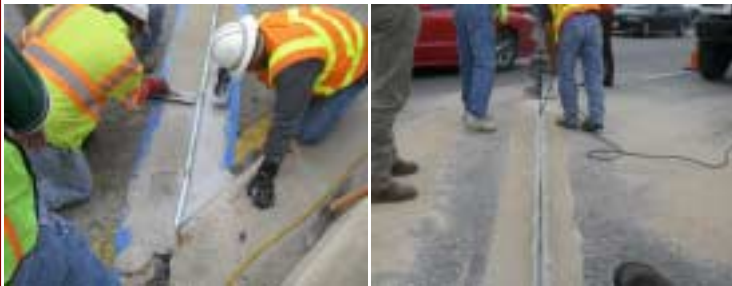
Measure out the amount of FlexKrete need for the job. (1) Mix catalyst into FlexKrete for 30 seconds, (2) add blast sand and mix for about 60 seconds, or until well blended, (3) empty onto surface and trowel into place. Allow about 30 minutes for curing, pull the tape and remove the spacer board, then, fill the joint. **Open to traffic in an hour or less!** FlexKrete saves time!

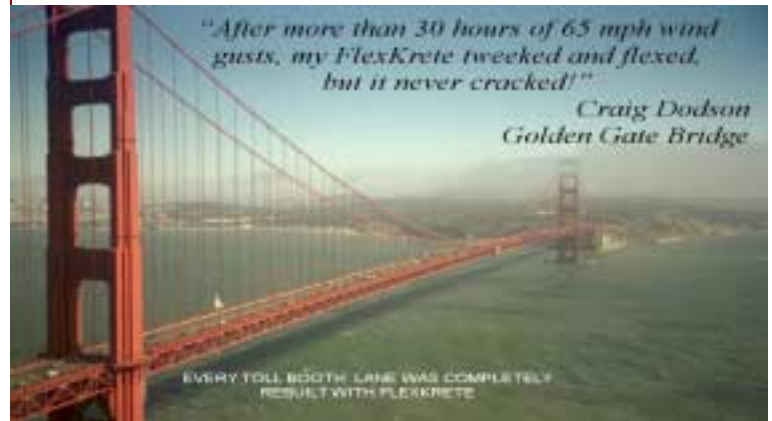
On the Golden Gate Bridge, FlexKrete has been in place for over two years, in depths of ½"- 6" deep, to rebuild 12'x50' toll booth lanes. This extreme harsh environment of constant wind, moisture, salt, fog and movement have not affected its performance. Indeed, here is what the maintenance manager of the GGB has to say about it.
